Technical Report HL-94-1  
May 1995

# **Demonstration Erosion Control Project Monitoring Program**

## **Fiscal Year 1993 Report**

### **Volume I: Main Text**

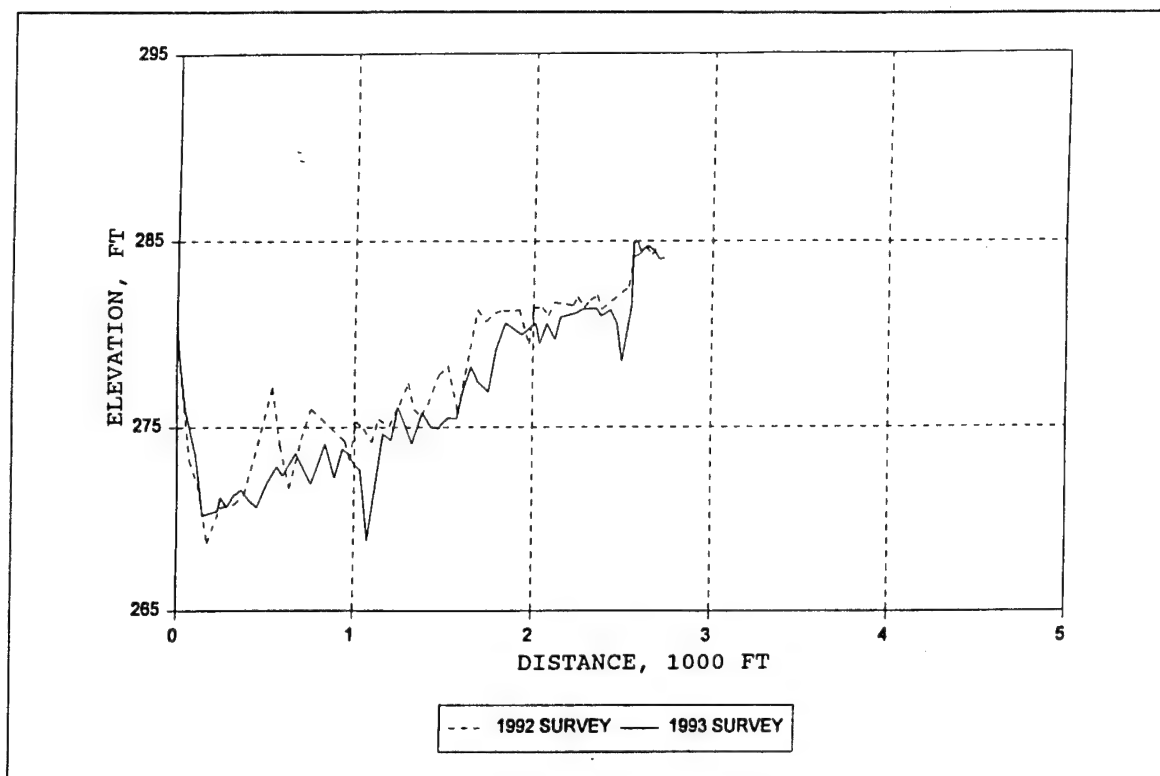
Figure 58. Comparison of 1992 and 1993 thalweg profiles for Marcum Creek

Figure 57 is a comparison of the 1992 and 1993 thalweg profiles for Hotophia Creek, and Figure 58 is a similar graph for Marcum Creek. These two graphs indicate change in the thalweg elevations. Some filling has begun upstream of the high-drop in segment 2, and minor degradation has occurred downstream of the high-drop in segment 1. Marcum Creek appears to have degraded in some locations approximately 3 ft, and degradation has moved upstream and is approaching the Marcum Creek low-drop. Downstream of the high-drop, the banks are failing and incision is continuing. Completion of the downstream high-drop should cause dramatic changes in this reach. Upstream of the existing high-drop, the bank appears to be relatively stable

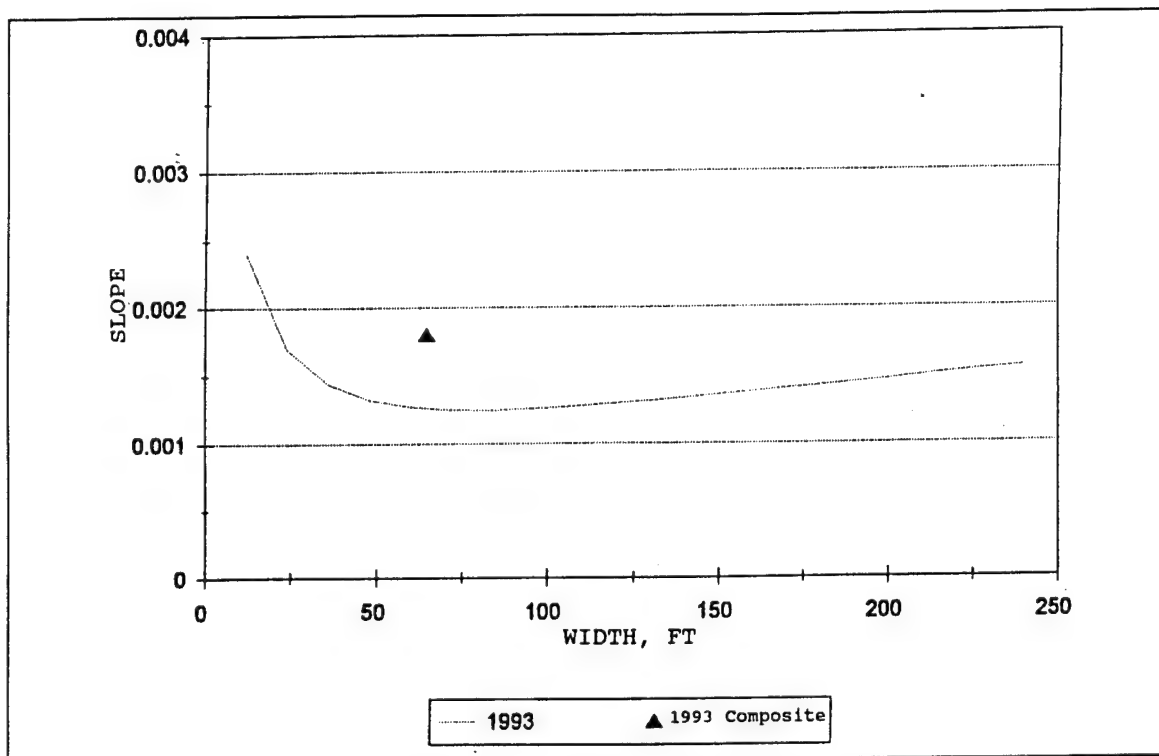
Figure 59. Comparison of the 1993 stable channel computations with the composite cross section for Hotophia Creek, segment 1

Table 9 is a summary of the data analysis for these segments. The effect of the existing high-drop structure is shown by the reduction of the energy gradient upstream of the structure from 0.0047 in 1992 to 0.00058 in 1993, by the reduction in slope from downstream to upstream, and by the reduction of surveyed channel slope and energy gradient on Marcum Creek and on Hotophia Creek upstream of the structure. Sediment transport capacity was reduced to only 3.4 percent of the prestructure amount for segment 2. This can be expected to increase as the pool fills, but a long-duration reduction can be expected. Completion of the upstream and downstream high-drops will have dramatic effects on the site, and additional sediment reduction and storage will be created. Figures 59, 60, and 61 compare the stable channel computations and the composite cross-section characteristics for segments 1 and 2 and Marcum Creek. Lower Hotophia appears to be degradational and will be affected by high-drop construction. The relationship between the 1992

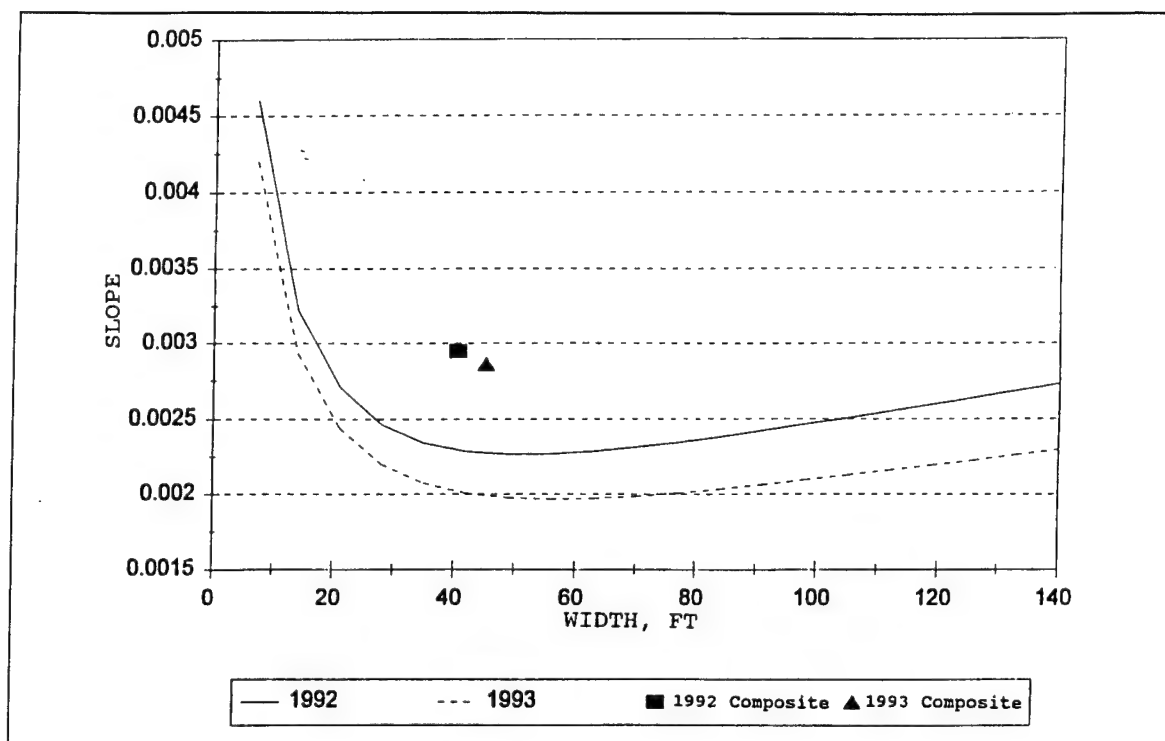
Figure 61. Comparison of 1992 and 1993 stable channel computations with composite cross section for Marcum Creek

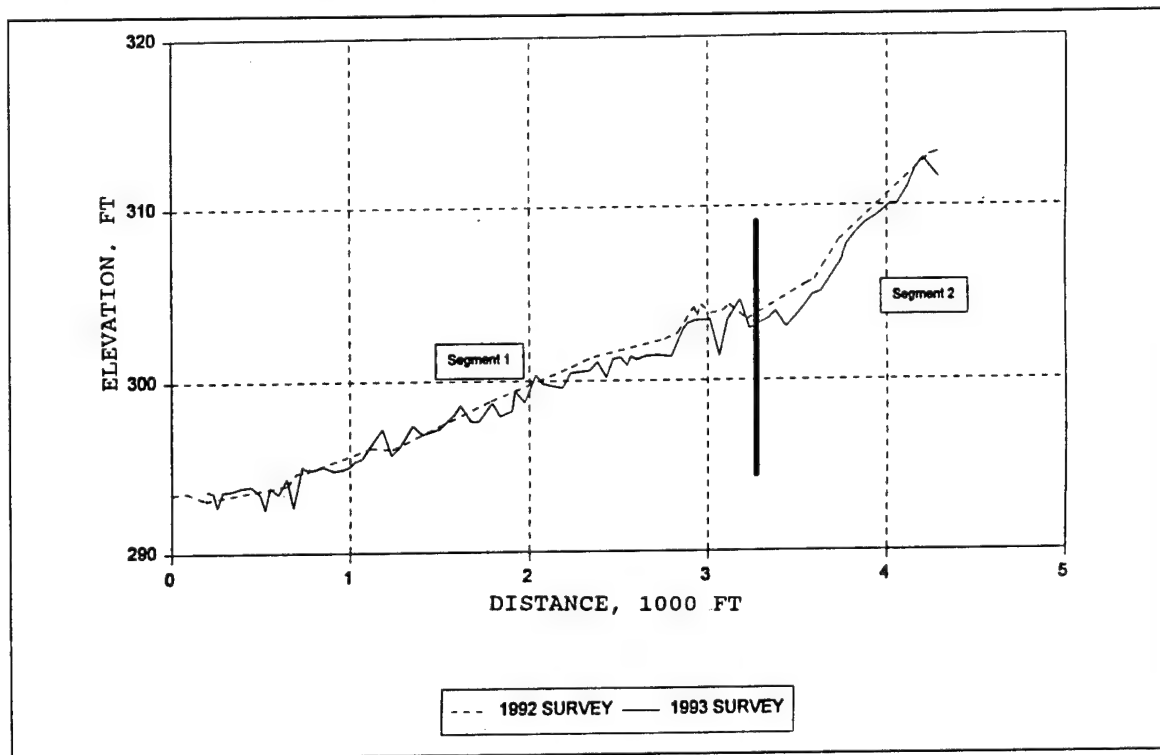
Figure 62. Comparison of 1992 and 1993 thalweg profiles for Nolehoe Creek, segments 1 and 2

Table 10 summarizes the data analyses for Nolehoe Creek, Site 7. The data indicate that segment 1 bed slope is about the same and the composite energy slope is decreasing. Figure 62 indicates minor degradation of the upstream portion of segment 1. Segment 2 is degrading as shown in Figure 62, and the data show that the bed slope is increasing. Figures 63 and 64 are comparisons of the stable channel computations and the composite cross-section characteristics. These figures generally indicate that the site is aggrading, which is not supported by other data. As discussed in the previous paragraph, this discrepancy was probably caused by use of a sediment size not representative of the total sediment transport.

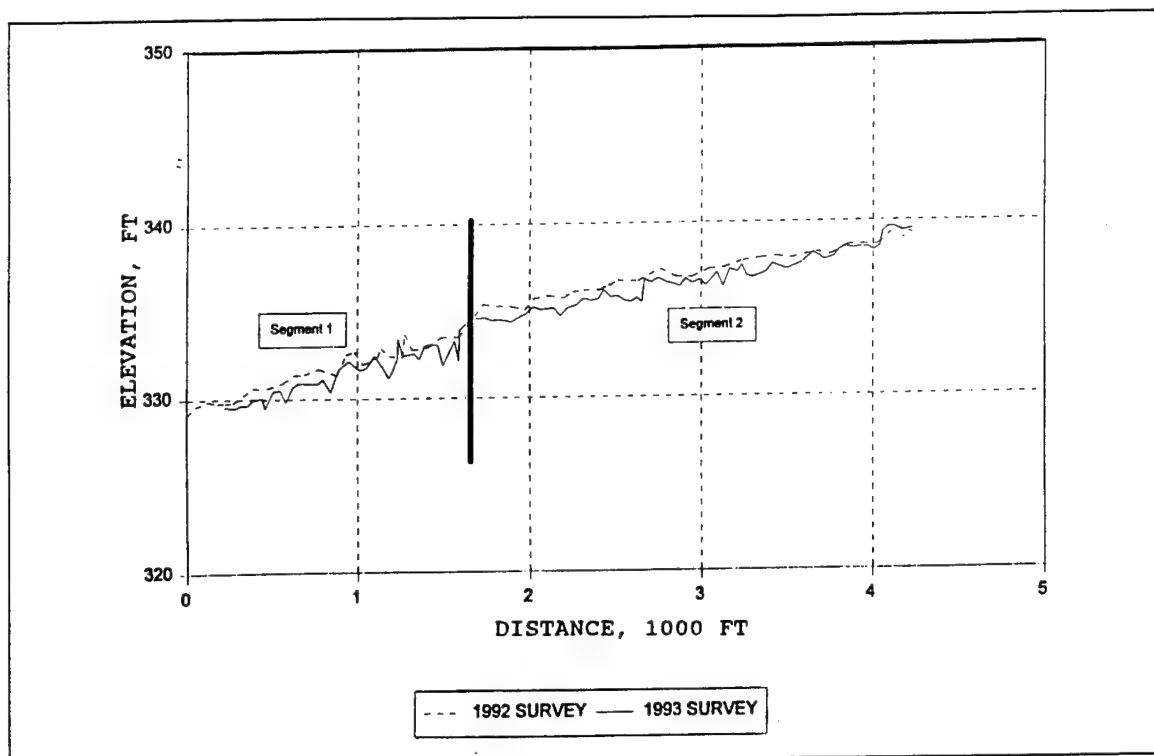
Figure 65. Comparison of 1992 and 1993 thalweg profiles for Sarter Creek

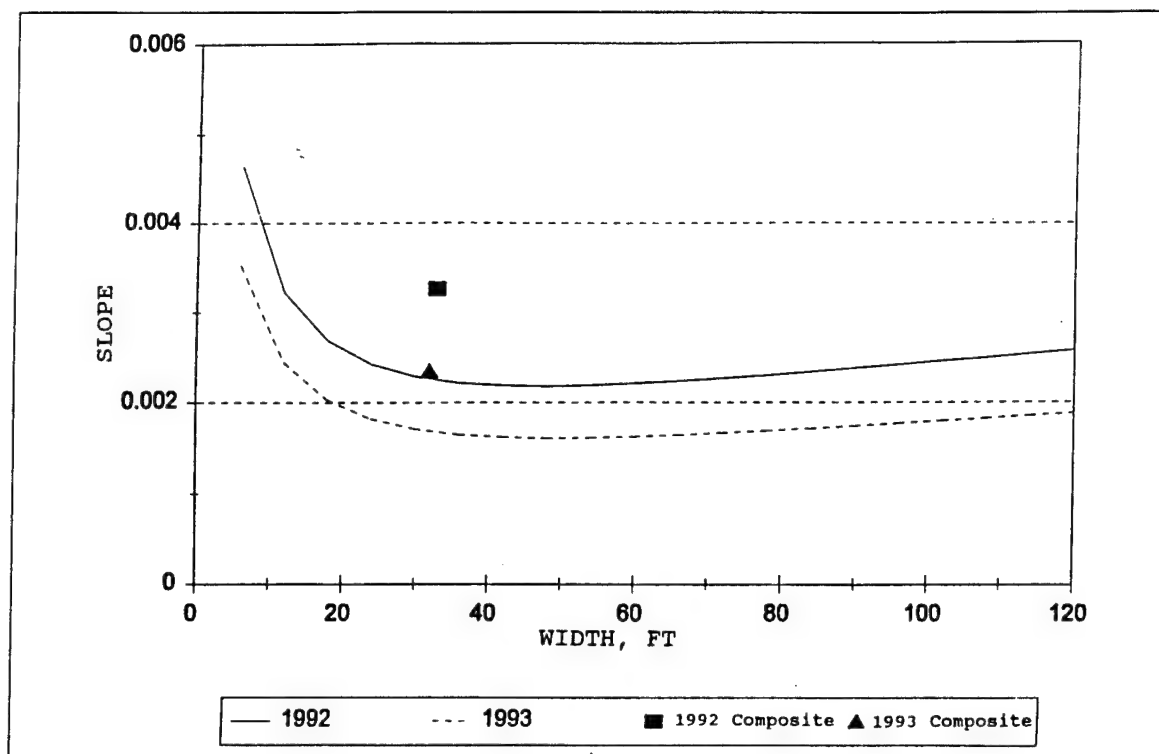
Figure 66. Comparison of 1992 and 1993 stable channel computations and composite cross-section characteristics for Sarter Creek, segment 1

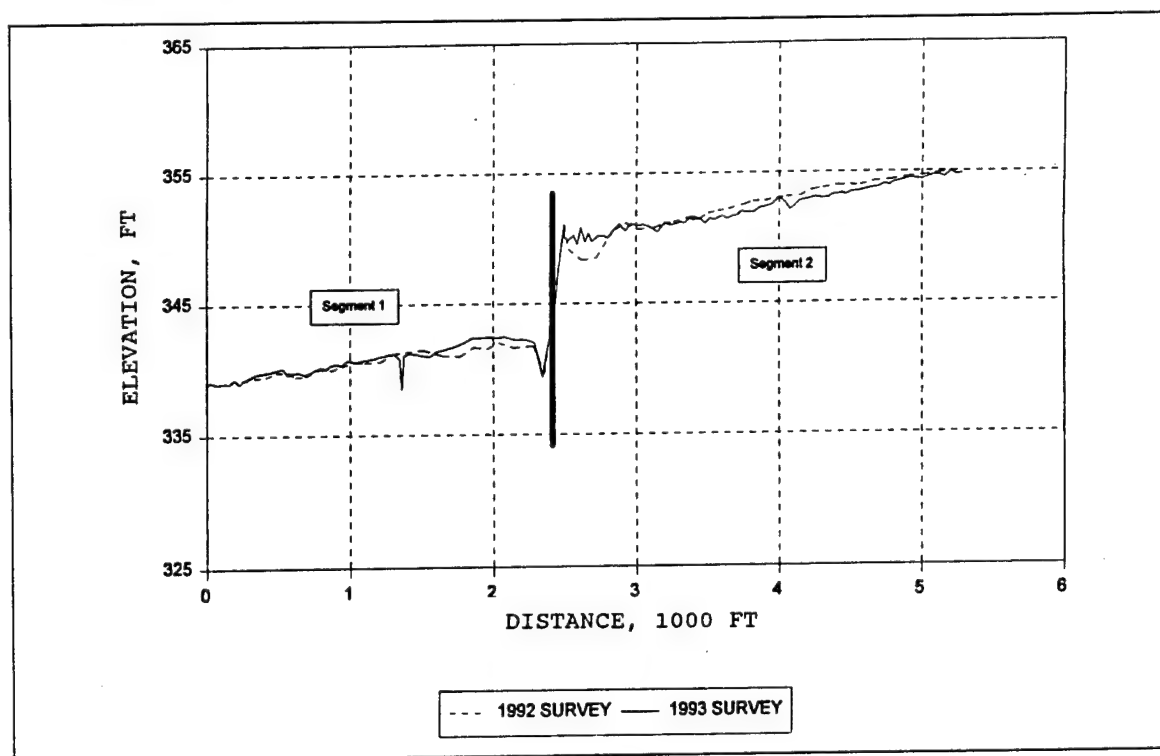
Figure 68. Comparison of 1992 and 1993 thalweg profiles for James Wolf Creek, Site 19

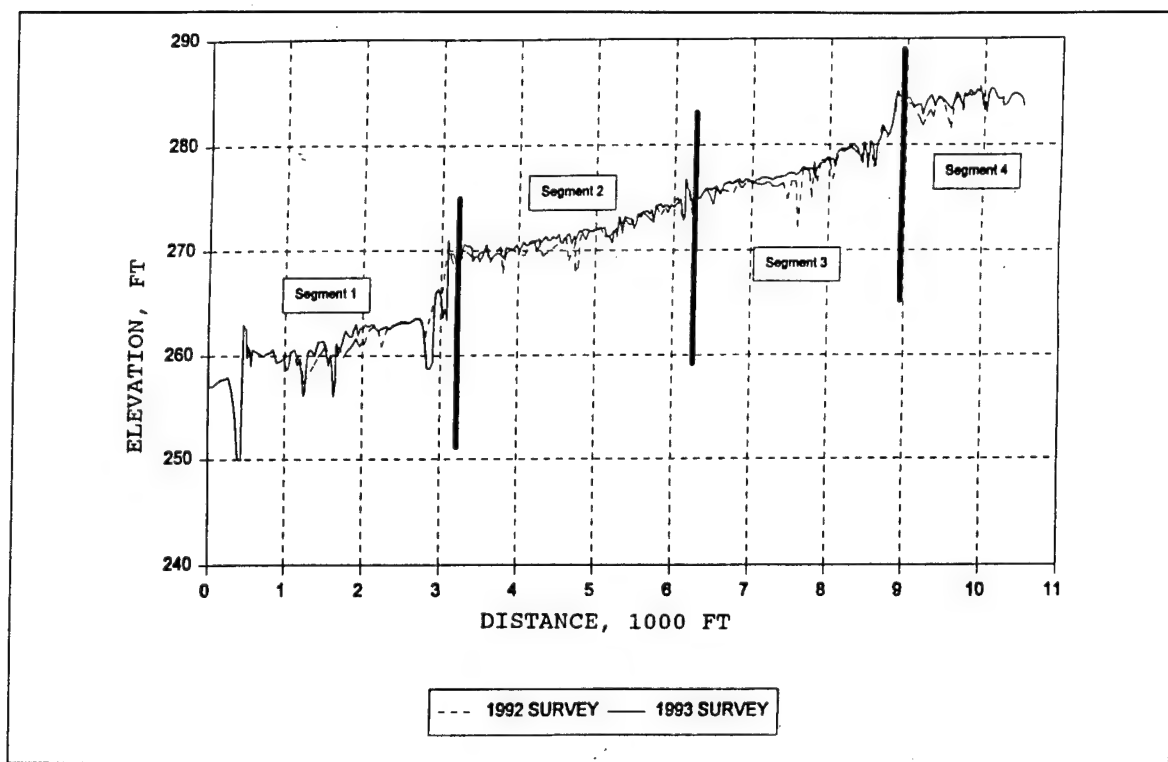
Figure 71. Comparison of 1992 and 1993 thalweg profiles for Long Creek

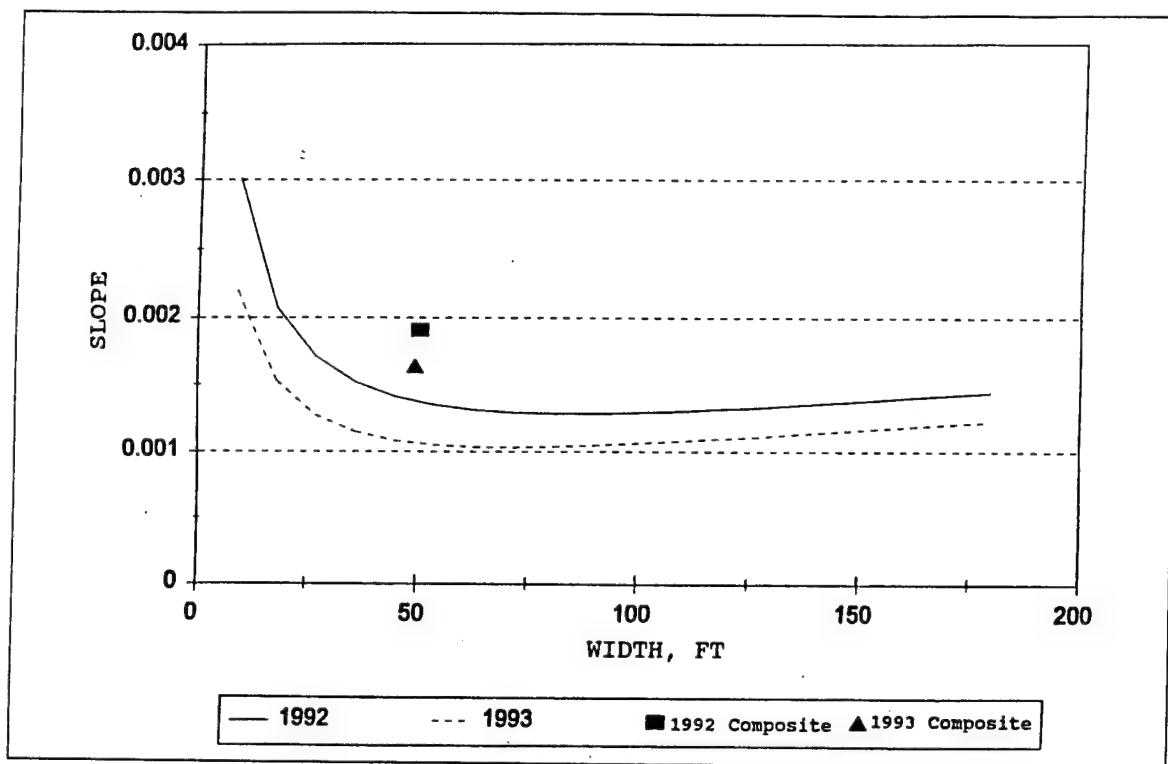
Figure 76. Comparison of stable channel computations and composite cross sections for East Worsham, segment 1

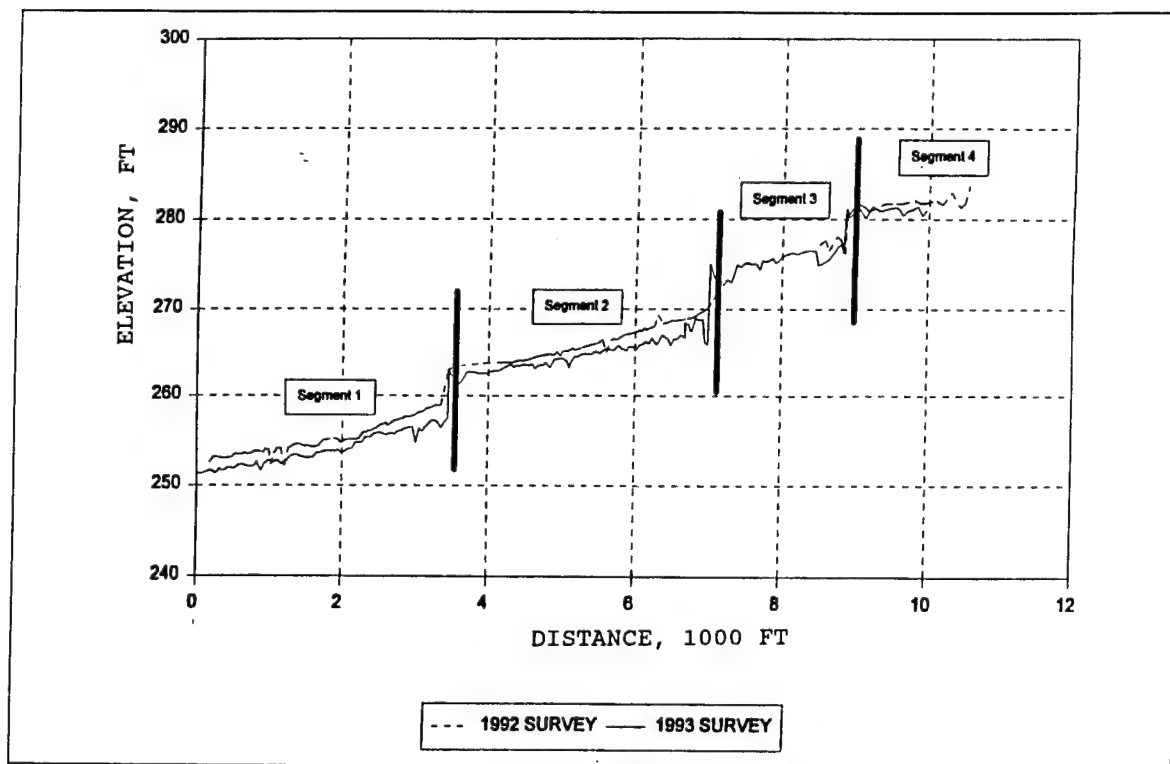
Figure 80. Comparison of 1992 and 1993 thalweg profiles for Middle Fork Worsham Creek, Site 18

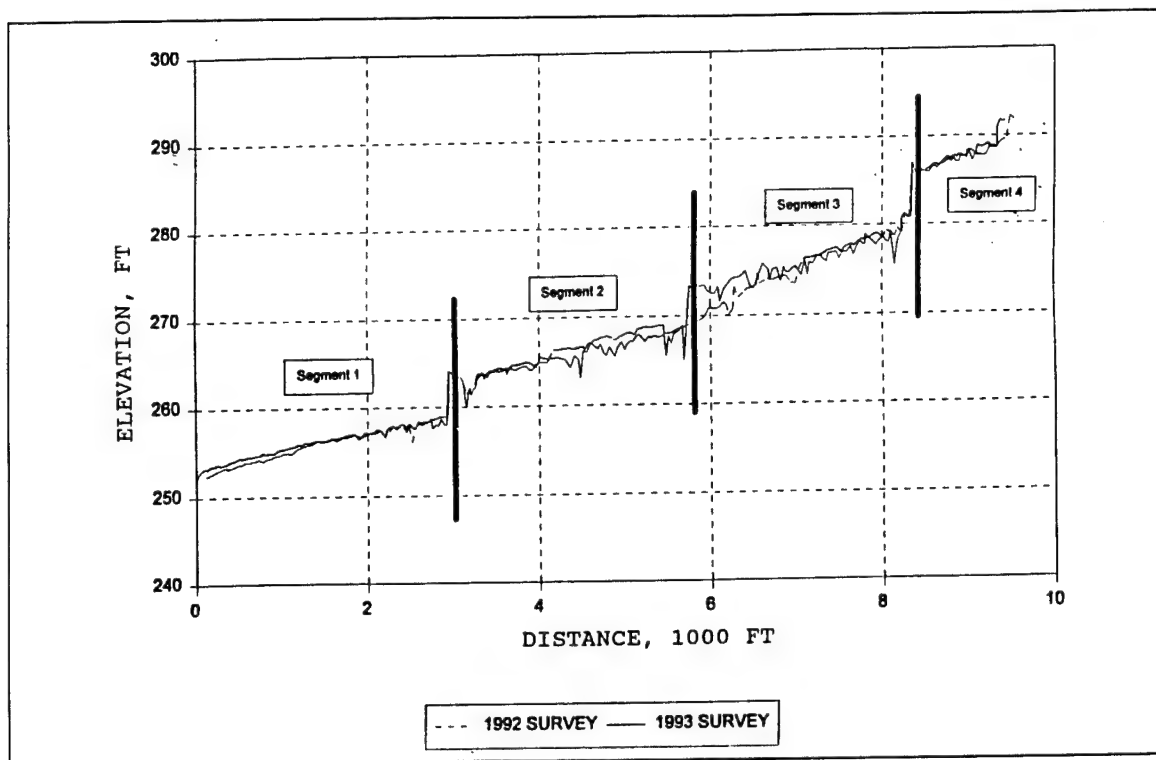
Figure 85. Comparison of 1992 and 1993 thalweg profiles for West Fork Worsham, Site 18

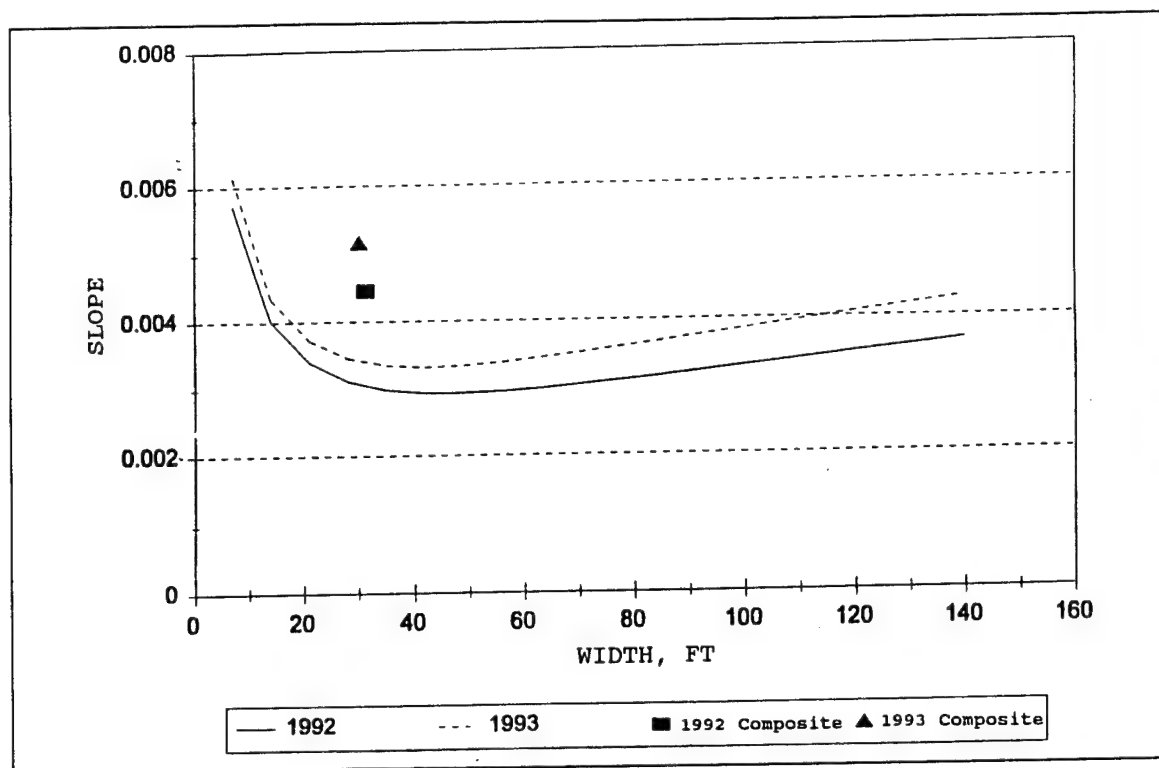
Figure 89. Comparison of 1992 and 1993 stable channel computations and composite cross-section data for West Fork Worsham Creek, segment 4

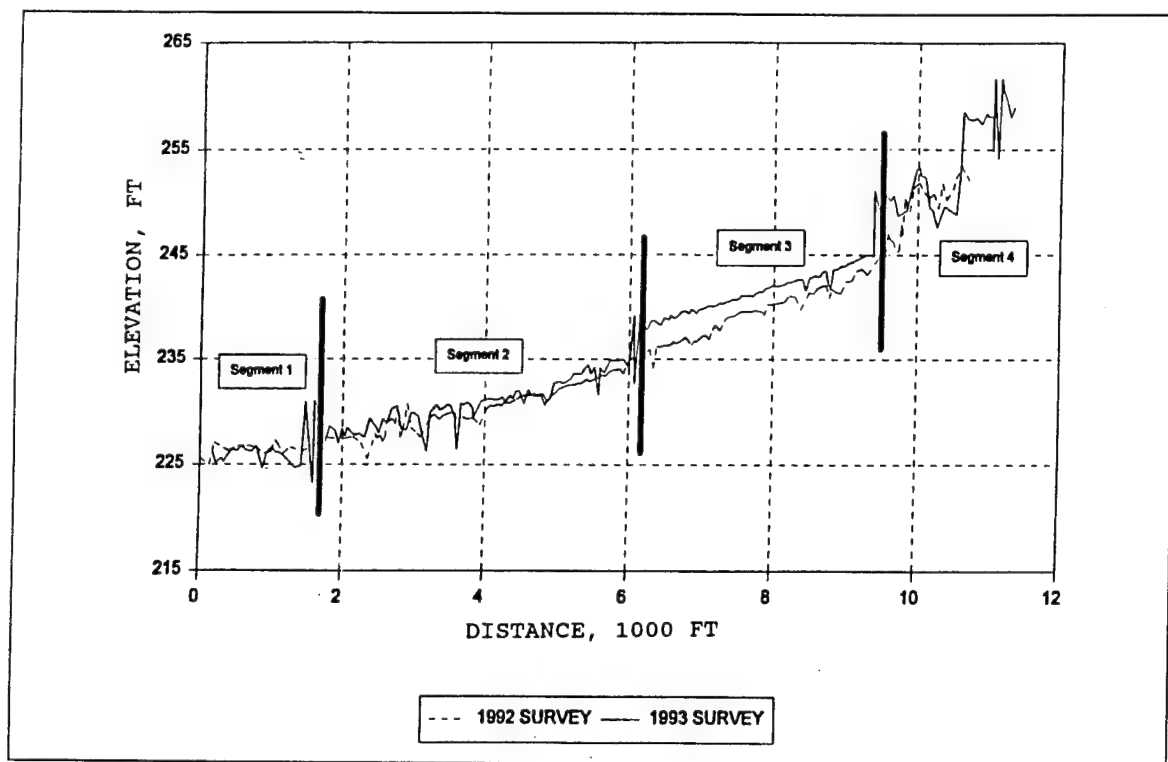
Figure 90. Comparison of 1992 and 1993 thalweg profiles for Perry Creek

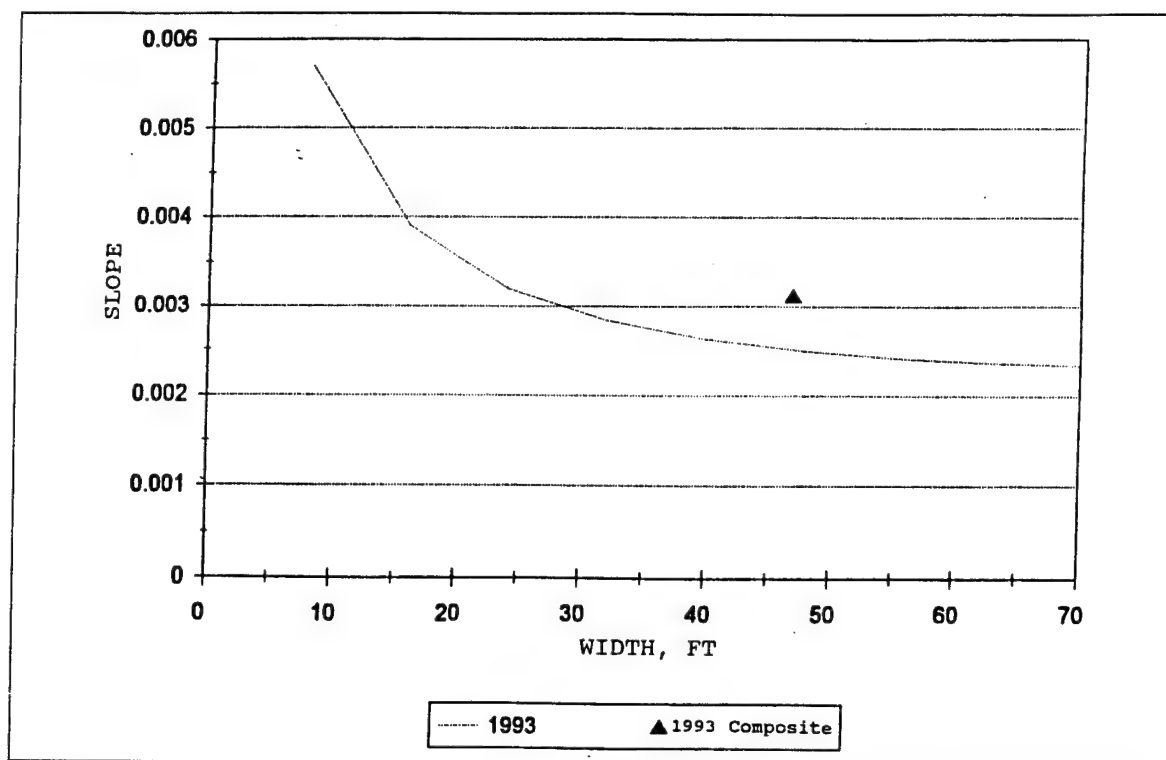
Figure 94. Comparison of 1993 stable channel computations and composite cross-section data for Perry Creek, segment 4

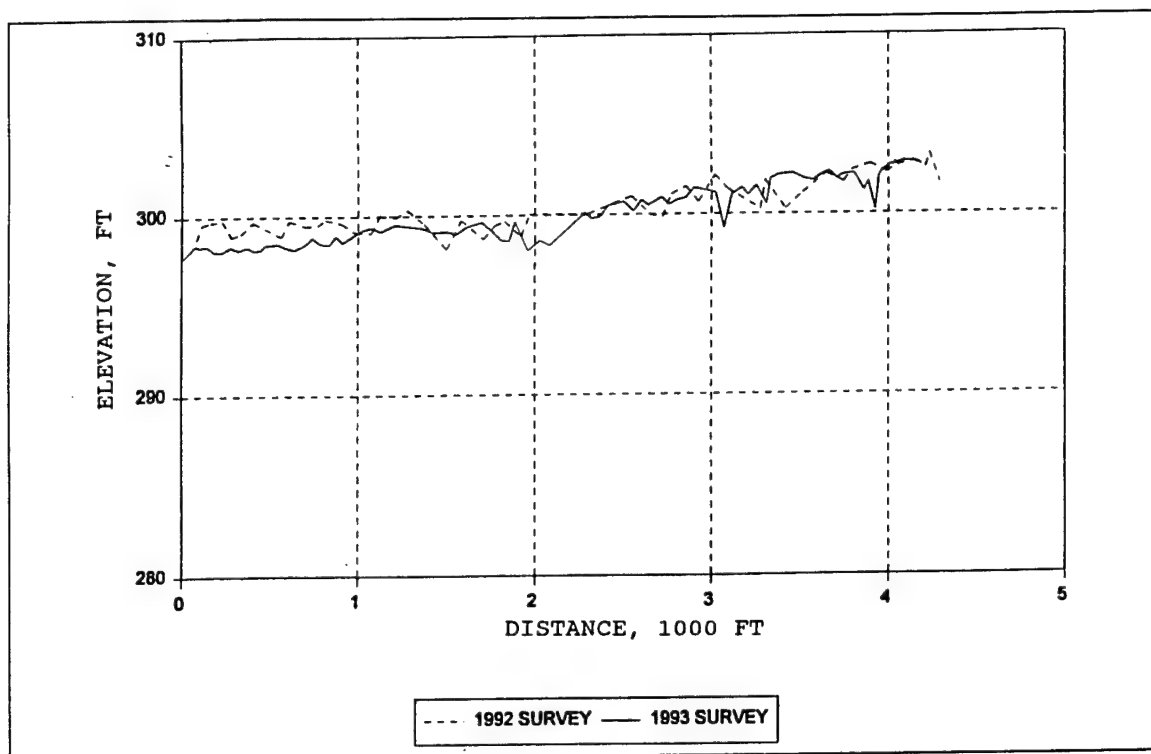
Figure 95. Comparison of 1992 and 1993 thalweg profiles for Otoucalofa Creek, Site 14

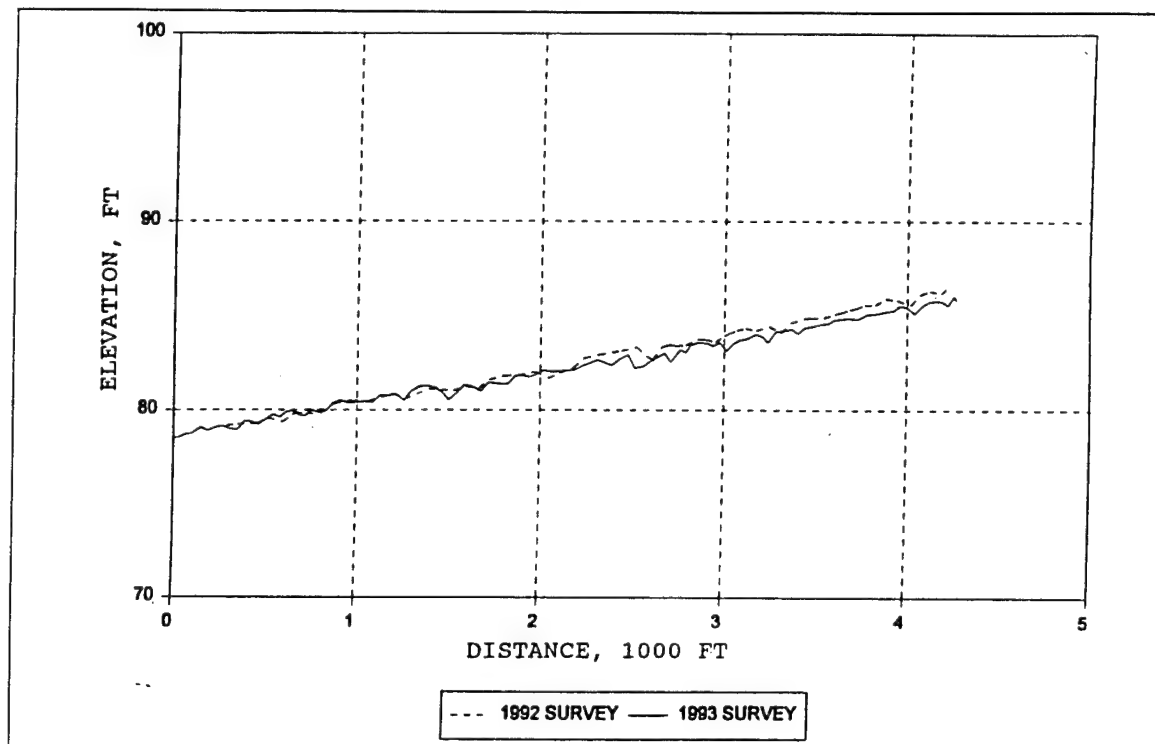
Figure 97. Comparison of 1992 and 1993 thalweg profiles for Sykes Creek, Site 17

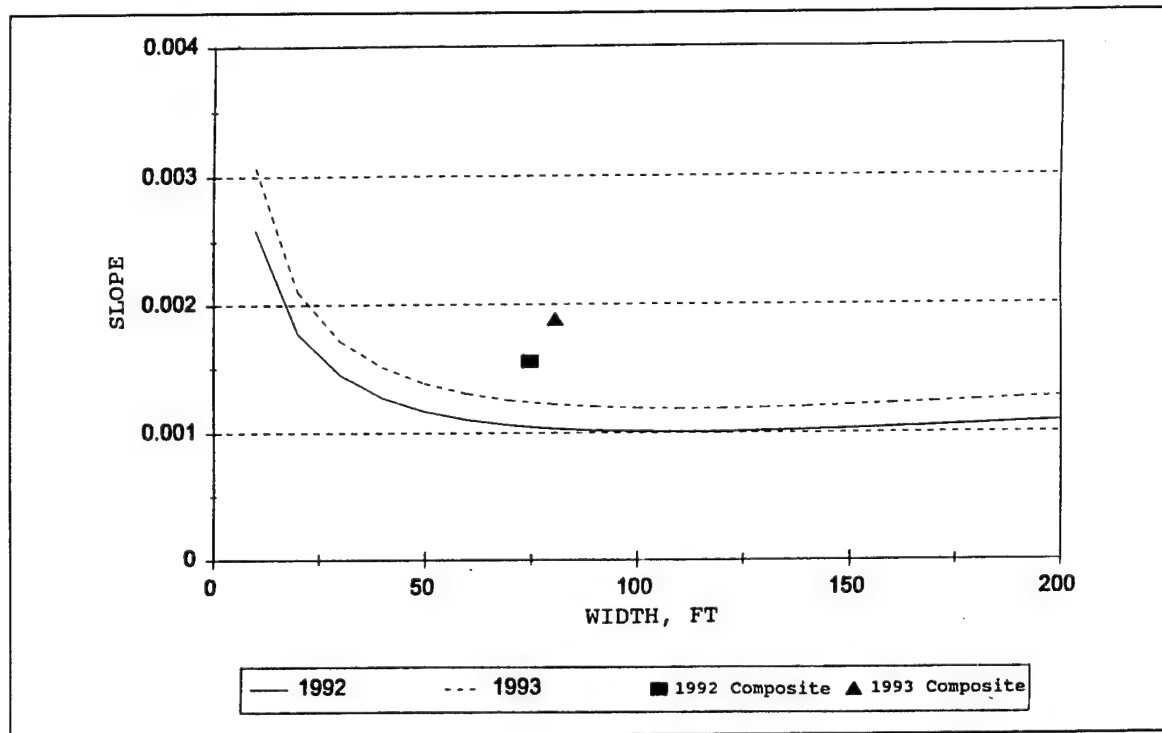
Figure 98. Comparison of 1992 and 1993 stable channel computations and the composite cross-section data for Sykes Creek, Site 17

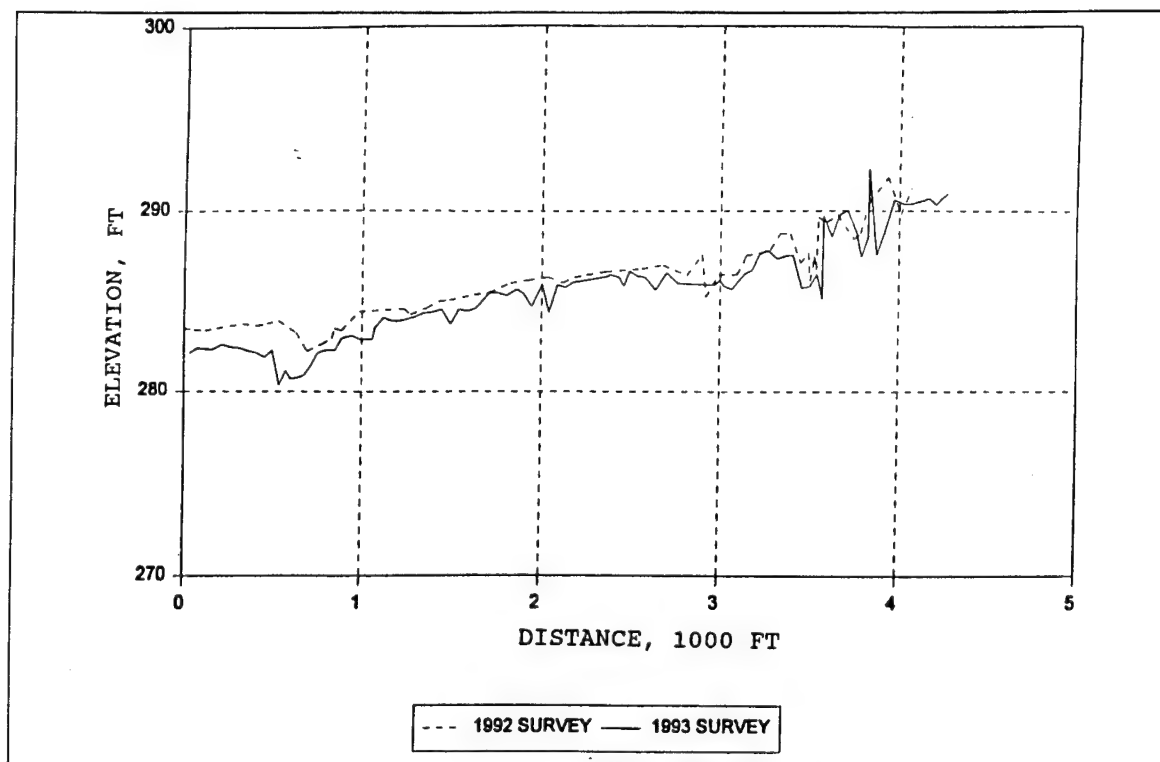
Figure 99. Comparison of 1992 and 1993 thalweg profiles for Fannegusha Creek, Site 2

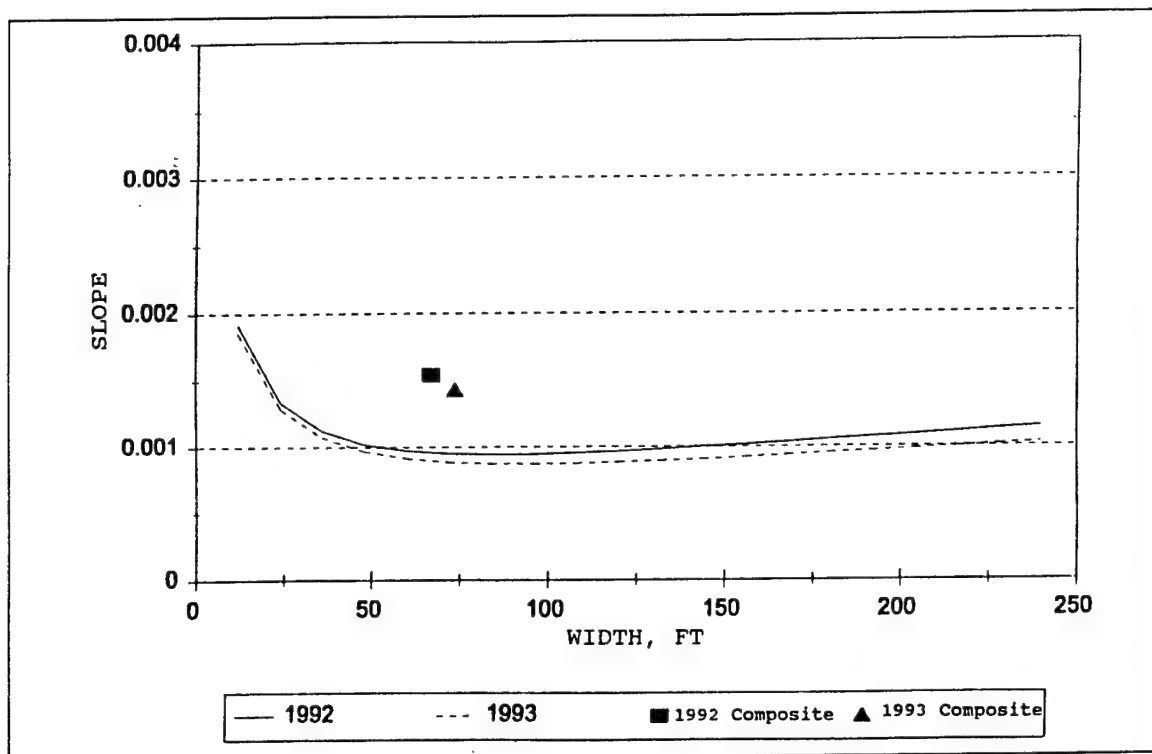
Figure 100. Comparison of 1992 and 1993 stable channel computations and the composite cross-section data for Fannegusha Creek, Site 2

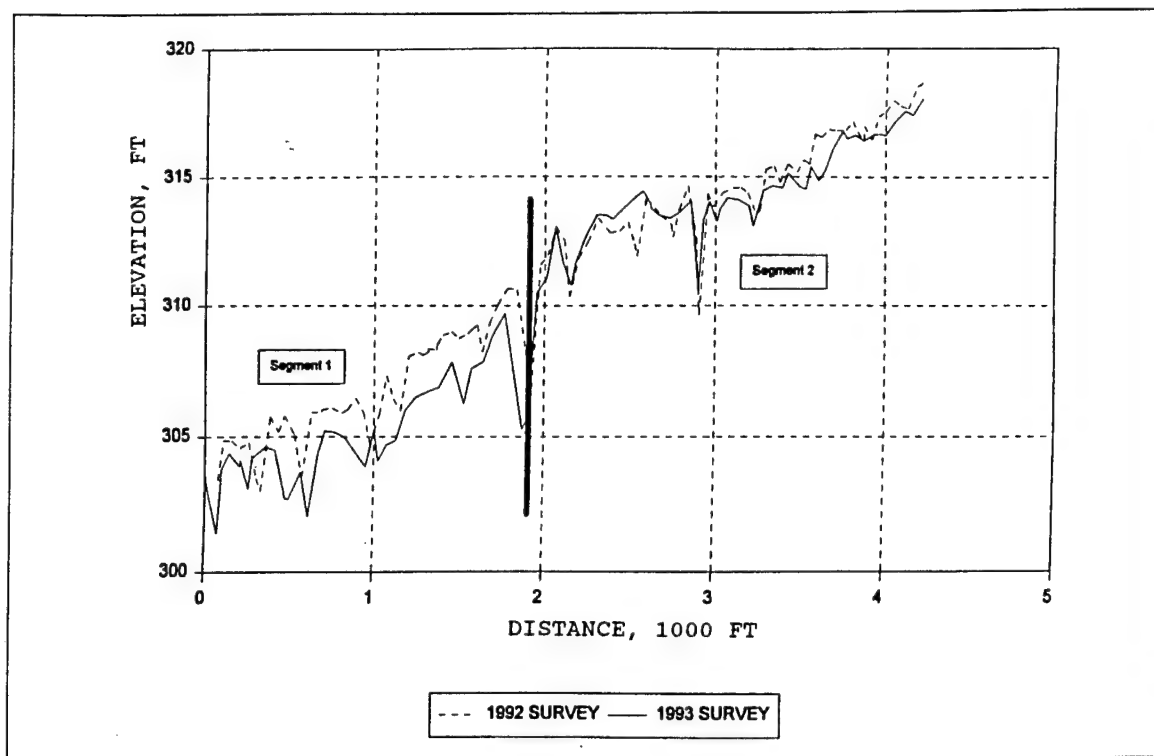
Figure 101. Comparison of 1992 and 1993 thalweg profiles for Lick Creek, Site 8

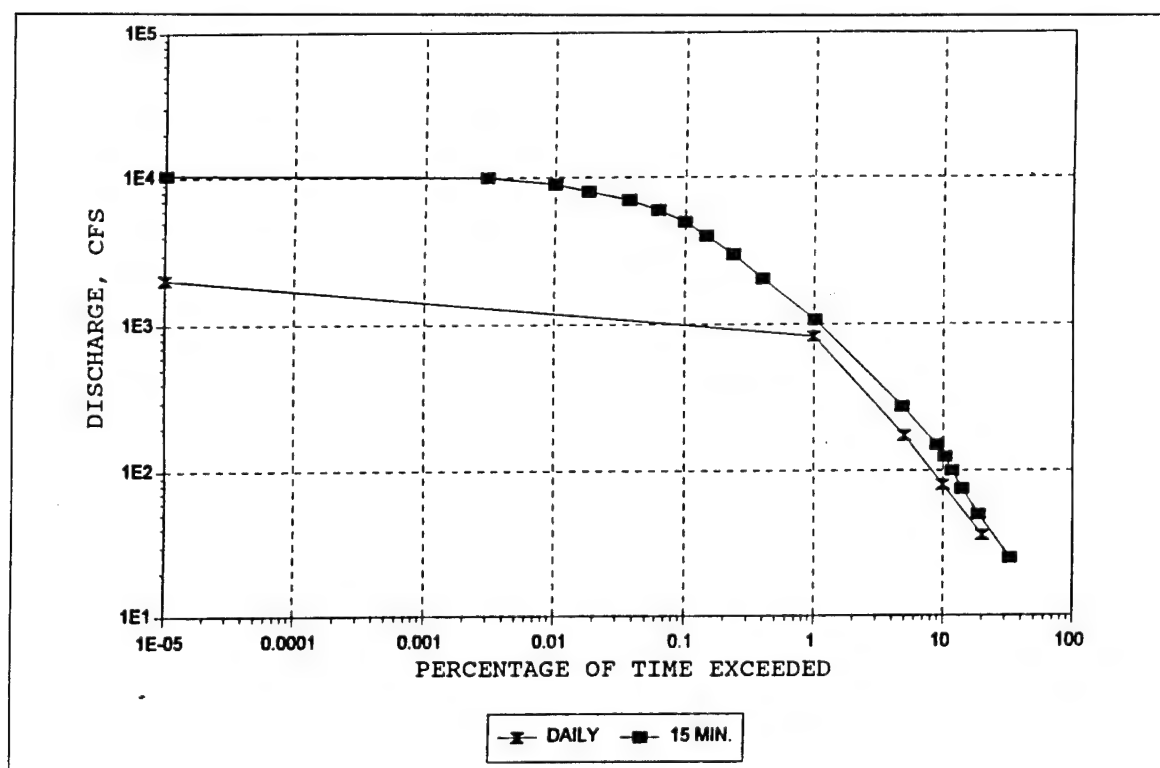
Figure 105. Comparison of flow-duration curves developed from mean daily discharge and 15-minute discharge sampling interval

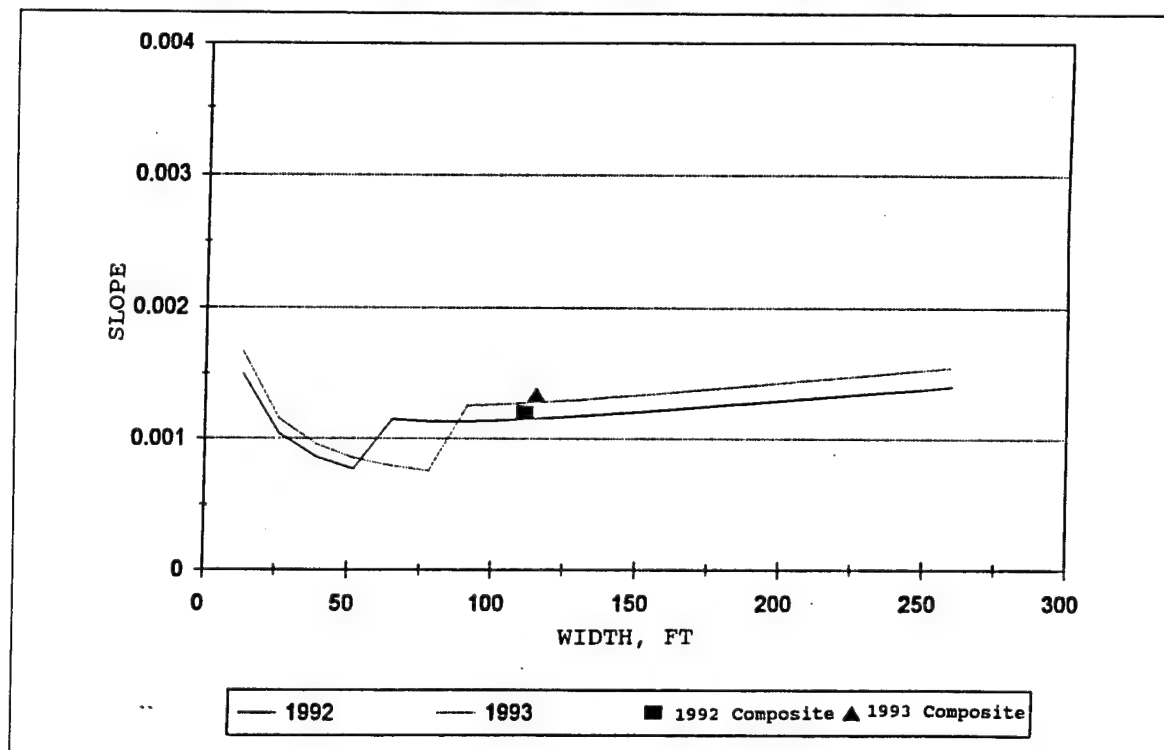
Figure 110. Comparison of stable channel computation and composite cross-section data for existing condition sediment yield of 124 tons/ft/day for 1992 and 137 tons/ft/day for 1993, Red Banks Creek, segment 1

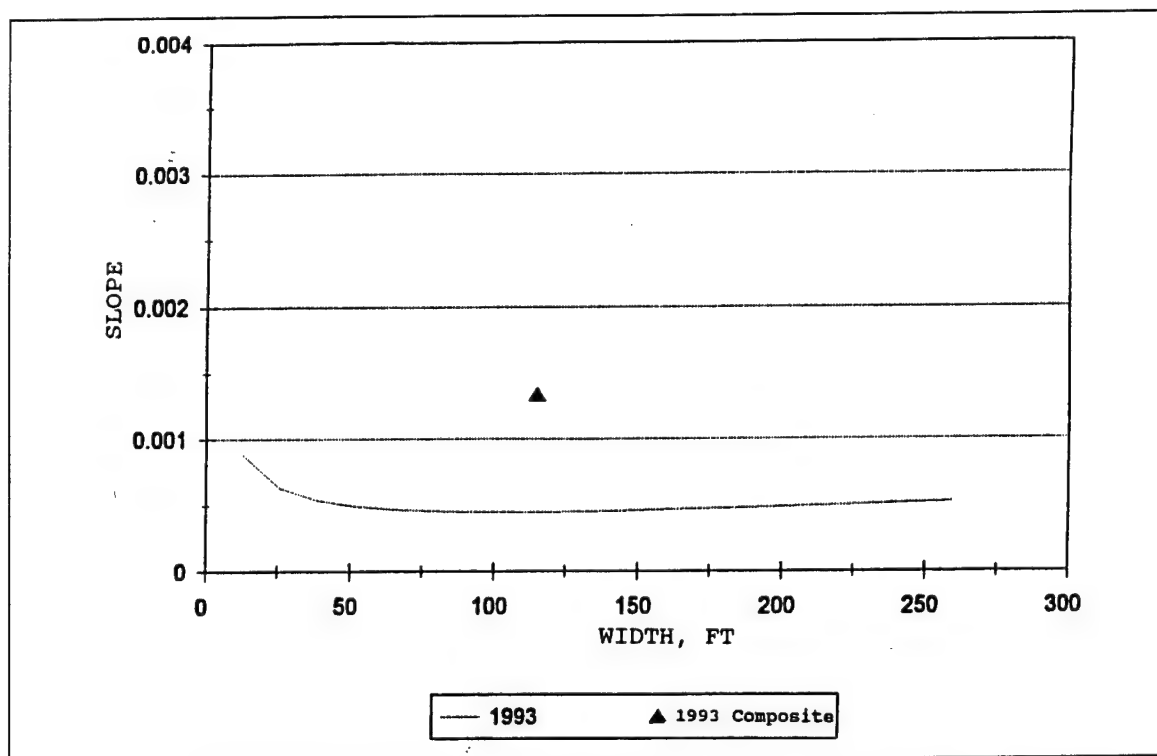
Figure 111. Comparison of composite cross-section data for 1993 with a stable channel computation for a hypothetical sediment yield of 30 tons/ft/day, Red Banks Creek, segment 1 (adjusted)

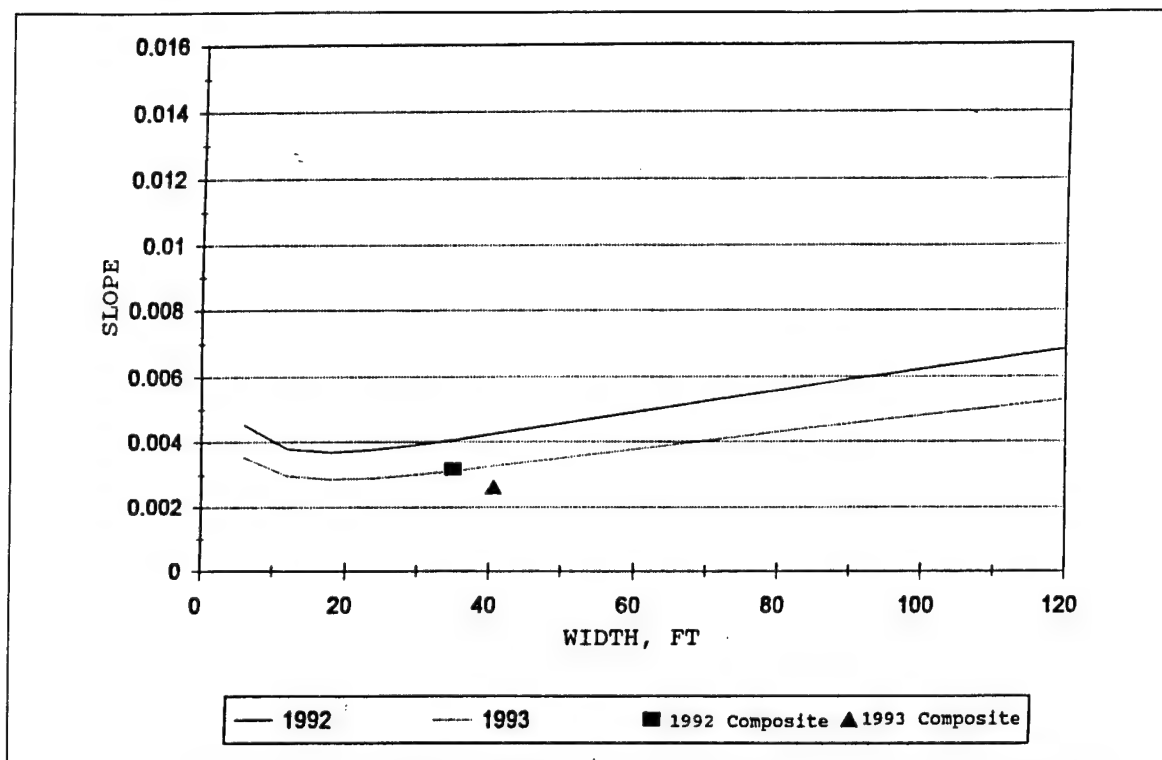
Figure 112. Comparison of 1992 and 1993 stable channel computation with composite cross-section data for the observed bed sediment,  $D_{50} = 10$  mm, Nolehoe Creek, segment 1
